Winnebago Journey Slide Support Repair

The slide support on the rear slide on my 2007 Winnebago Journey failed causing the slide to sag. The bottom plate was damaged from rubbing on the edge of the failed metal post.

The following will show how I was able to replace the failed post with one of my design without removing the slide.

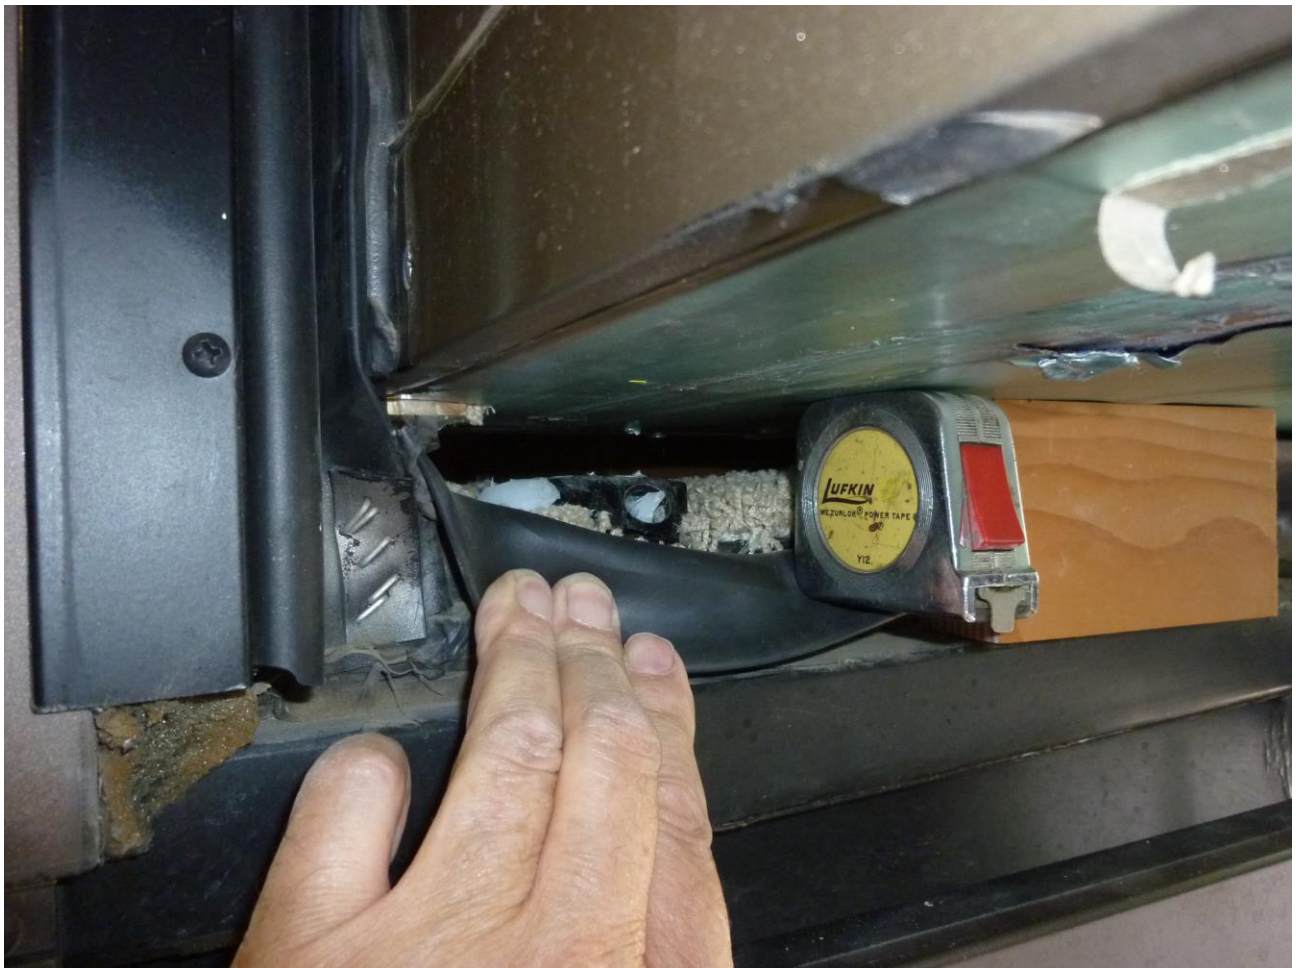
For added safety, I cut a piece of 2x4 to 3" long and placed it next to the repair area. Here is a picture of the damage. The tape is a 3rd hand to keep the rubber out of the way.

The first thing to do is level the coach with the jacks and then extend the slide most of the way out and support the slide with a saw horse and jack or whatever you have that can handle the weight. I jacked the slide box up until I had 3" between the bottom and the support tubing where the post socket is located.

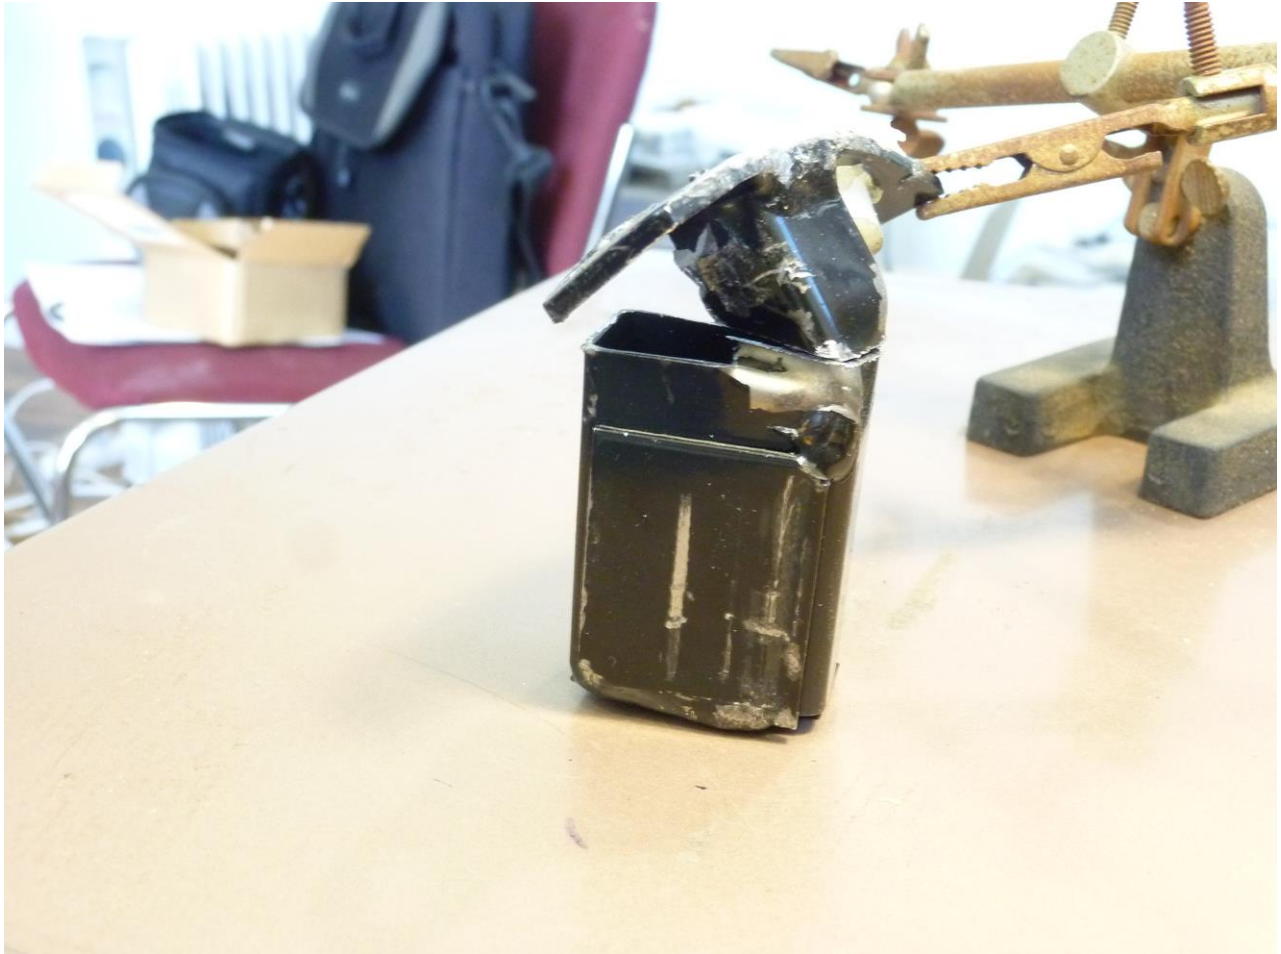
This is what the post looked like after it was removed and held together on my bench.

I have no idea why Winnebago cut the post as they did but it is a failure just waiting to happen.

The only way I could remove the damaged post was to cut it in half with a hacksaw.

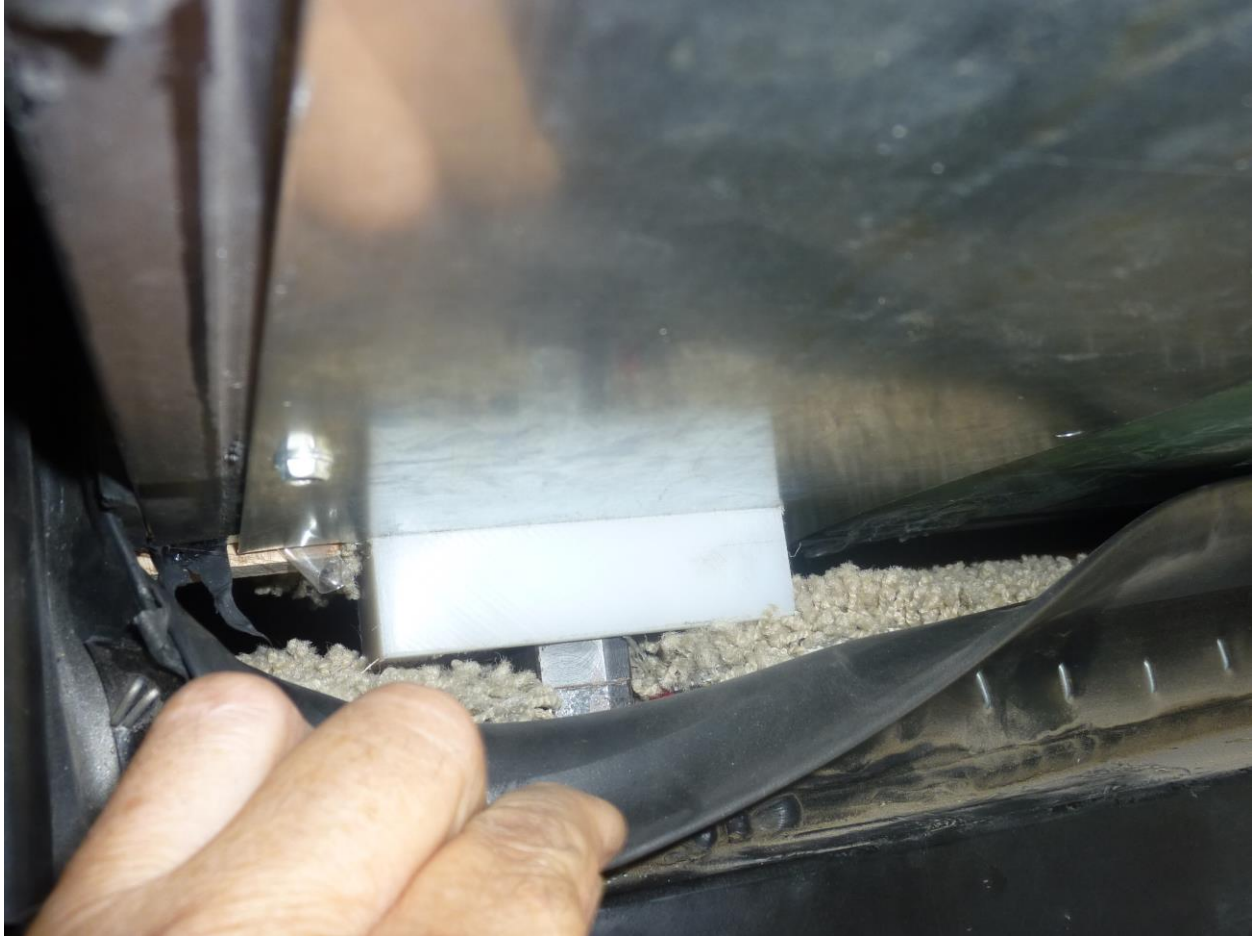
At the end is my drawing of the new post. By using two pieces for the post and adding the top plate, you are able to assemble it in place working in the 3" space. As one of the pictures shows, I had to grind one corner of the post in order to tip it into the socket.
